## NORTHERN HUB - STRUCTURE DSE146 SPAN 19 T-MAT 80 JOINT & BEARING INSTALLATION

Temporary works, bridge jacking, installation of 2 no. T-Mat 80 expansion joints, 3 no. mechanical and 23 no. elastomeric bearings.

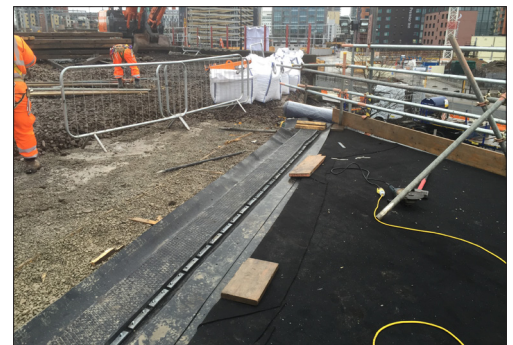
T-Mat 80 expansion joint installed

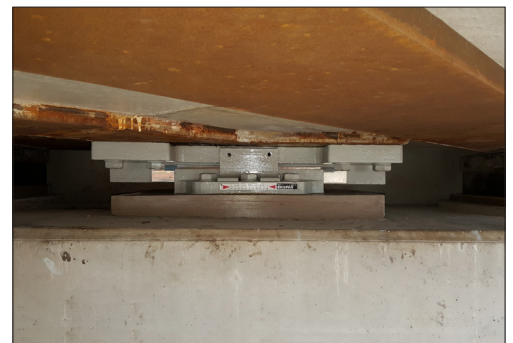
Mechanical bearing installed

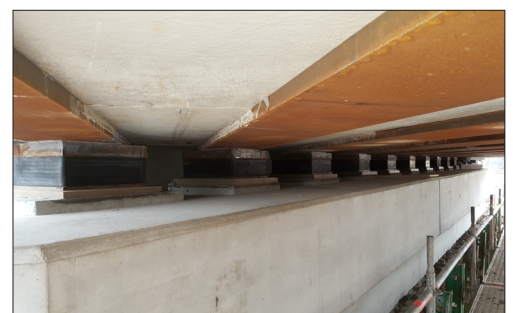
Elastomeric bearings installed
