## MANCUNIAN WAY FLYOVER - REMOVAL & INSTALLATION OF GUIDE BEARINGS

### Project Brief

Supply and installation of 2 no. guide bearings

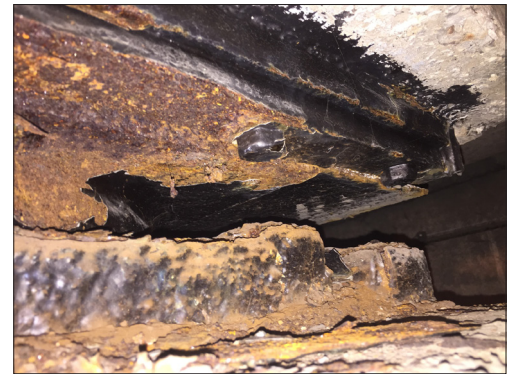
The Flyover was built the same time Mancunian Way was extended east in 1992, and over time vehicular impact on this heavily used structure has caused considerable wear on the bearings which consequently have required periodic scheduled maintenance / replacement.

*Existing bearing showing delamination and corrosion before removal*

USL Ekspan were instructed to remove the 2 damaged bearings identified and replace these with 2 new guide bearings.

As jacking points were not present on the bridge additional specialist jacking had to be implemented using a propping system with temporary bearings. Without these removal and installation of the bearings would not have been possible.

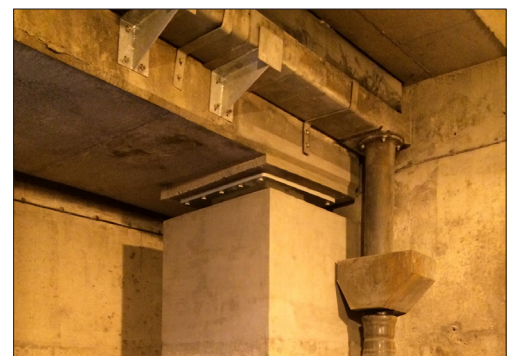
*New guide bearing installed*
