# A473 BRIDGEND INNER BYPASS BRIDGE, SOUTH WALES BEARING REMOVAL & INSTALLATION

### Project Brief

Removal of 65 no. rocker bearings. Design, manufacture, supply and installation of 65 no. mechanical pot bearings.

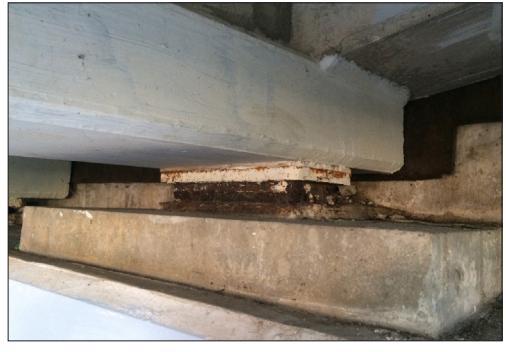
The steel bearings supporting the bridge deck were excessively corroded to the extent that some had 'seized', and were consequently deemed as being inadequate to accommodate the expansion and rotational forces which they were originally designed for. To alleviate this increased stress transferred into the bridge deck and supports, these bearings had to be replaced.

Old rocker bearing corroded and no longer functional

USL Ekspan were contracted by Dyer & Butler to replace the existing 65 no Glacier steel rocker bearings with USL Ekspan BS5400 mechanical pot bearings on the West abutment, at the East and West piers of Bridgend inner bypass bridge. Due to the complexity of the structure's design and the existing bearing dimensions, the new installed bearings were designed and manufactured as bespoke pot bearings.

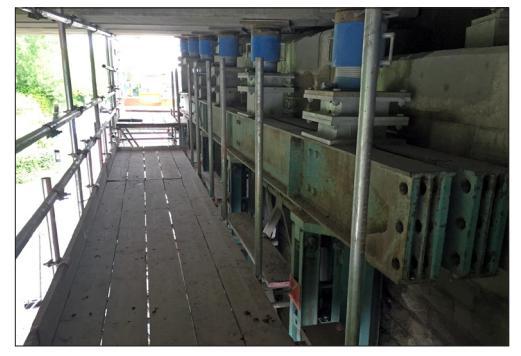
Super props and jacks temporarily supporting the bridge deck

Works on this project included marking-up and prepping site for installation of temporary works / bridge propping; hydro demolition of bearing / bridge beams, piers and abutment; bearing removal; construction and installation of steelwork beams as plate/stool arrangements for the new pot bearings to be fixed to; bearing installation; concrete repairs works for encapsulation of steelworks and bearing top plates and base plate sockets; concrete repair to piers and abutments and final grouting of the new installed bearings.

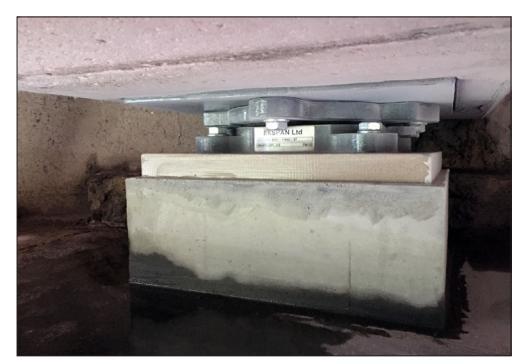
New installed mechanical pot bearing fixed to the bridge beam and bearing shelf
