## PUMPHOUSE VIADUCT - A5189 ST. PETER'S BRIDGE BEARING REPLACEMENT

### Project Brief

Bridge jacking and temporary works design and installation.

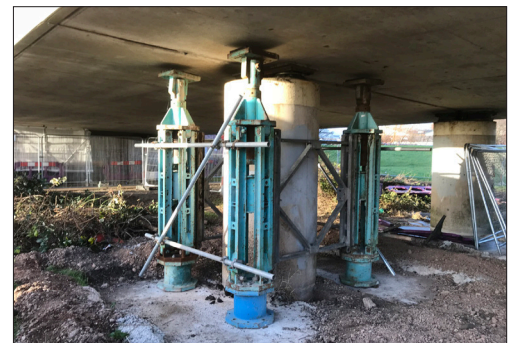
*Super props temporarily support the bridge deck during bearing installation*

USL Ekspan designed (to EN1337 standards), manufactured and installed 16 no. stainless steel free and guide spherical bearings. The programme of works for this installation was completed in two phases with careful planning of temporary works, bridge jacking and bearing removal sequencing with Mabey Hire to constrain and monitor the structure. Works on this project included: design and installation of temporary works and bridge jacking; hydro demolition of the top piers and abutments; removal of old spherical bearings; installation of new bearings; recasting of concrete; shuttering and grouting of new bearing beds and final de-jacking of the bridge.

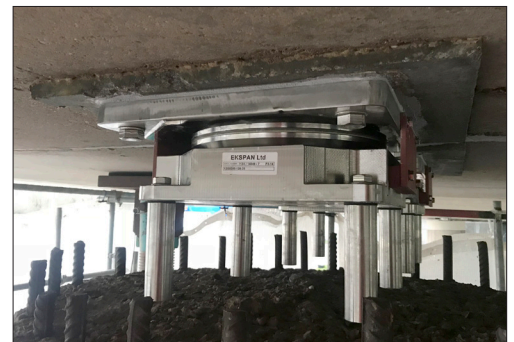
*New stainless steel spherical bearing - pre-concrete works*

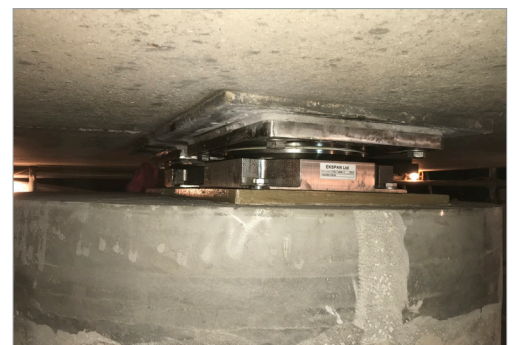
*Completed installation of stainless steel spherical bearing*
