Tamar Bridge & Torpoint

USL Ekspan

A38 TAMAR BRIDGE - REMOVAL & INSTALLATION OF FIP EXPANSION JOINTS

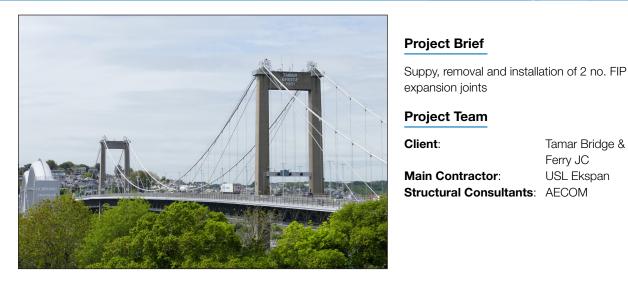
the main bridge deck carriageway

FIP expansion ioint installed

The successful installation of the FIP expansion joints at Saltash main tower and Plymouth main tower (July 2015), attributable to meticulous pre-planning, involved 2 teams of USL Ekspan operatives working continuous throughout including nightshifts on 2 consecutive weekends during a complete 3 lane closure.
